Inspection Photos  
Location Name: Vetting /15-H  
Location ID: 322888

**VETTING FACILITY  
 NOTIFICATION MAP**

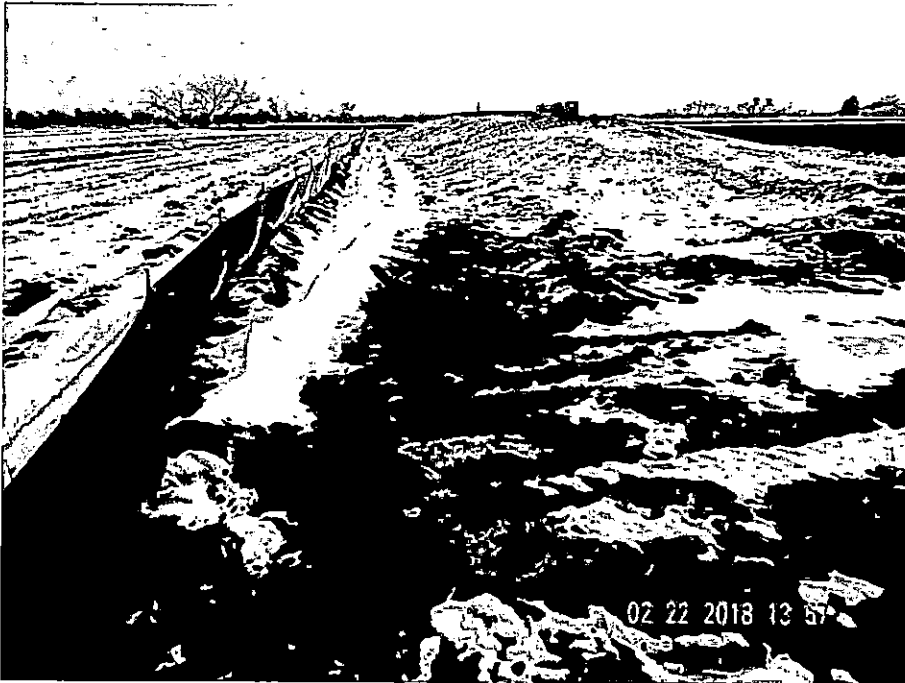
**Photo 5.** Photo taken from the northeast location, facing South. See comments under Photo 1.
