Colorado State Capitol Grounds  
**Cultural Landscape  
Report**

August 2019

Prepared for  
Colorado Legislative Council of the  
Colorado General Assembly

Prepared by  
**Mundus Bishop**

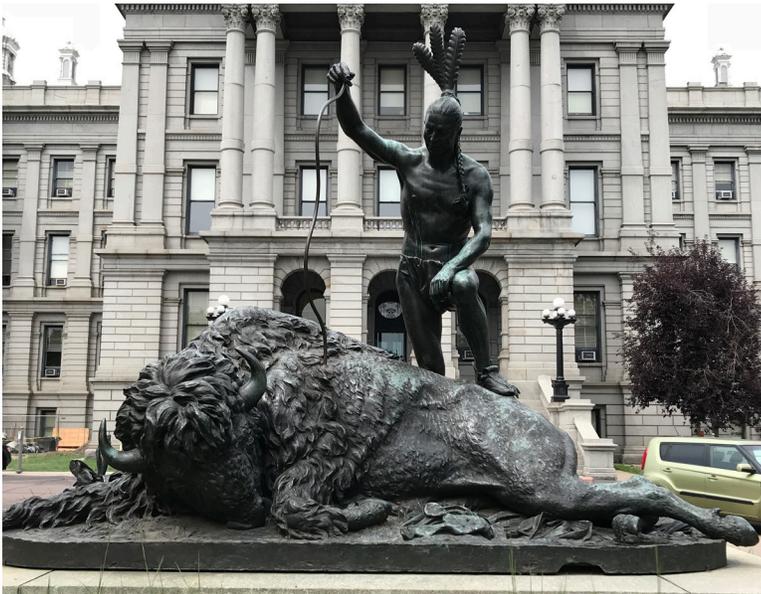
Figure 1-3. *The Closing Era* sculpture. (Mundus Bishop, 2018)

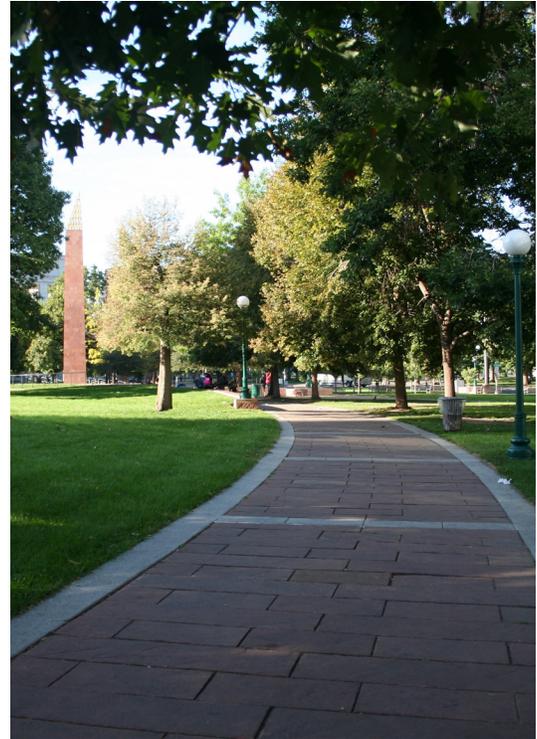
The *Colorado Veterans Monument* was added to Lincoln Park, replacing an earlier 140-foot flag pole. The three-sided obelisk is 45 feet tall, constructed of red Lyons sandstone, and topped with a bronze and onyx cap. It is set within a plaza paved with red sandstone and granite. A central east-west planting bed is enclosed with a low sandstone wall to the east of the monument.<sup>2.47</sup>

Figure 2-20. Colorado Veterans Monument obelisk and elliptical walk. (Mundus Bishop, 2018)

The greatest change to the Schuetze plan's spatial organization occurred in 1990 with the addition of the *Colorado Veterans Monument* in Lincoln Park. A paved plaza, widened central walk, and 45-foot sandstone obelisk replaced the original flagpole and simple space where the semi-elliptical walks converged. The monumental addition alters Lincoln Park's naturalistic experience and views.

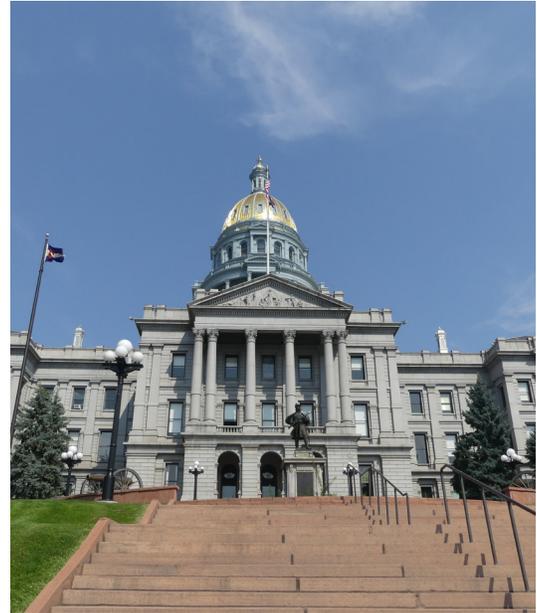
Figure 3-2. Capitol Building’s western elevation. (Mundus Bishop, 2018)

Capitol Building dominates the eastern edge of the study area. The Renaissance Revival building reflects the setting and form of the United States Capitol in Washington, D.C. The building's interior and exterior were recently restored and are in good condition.

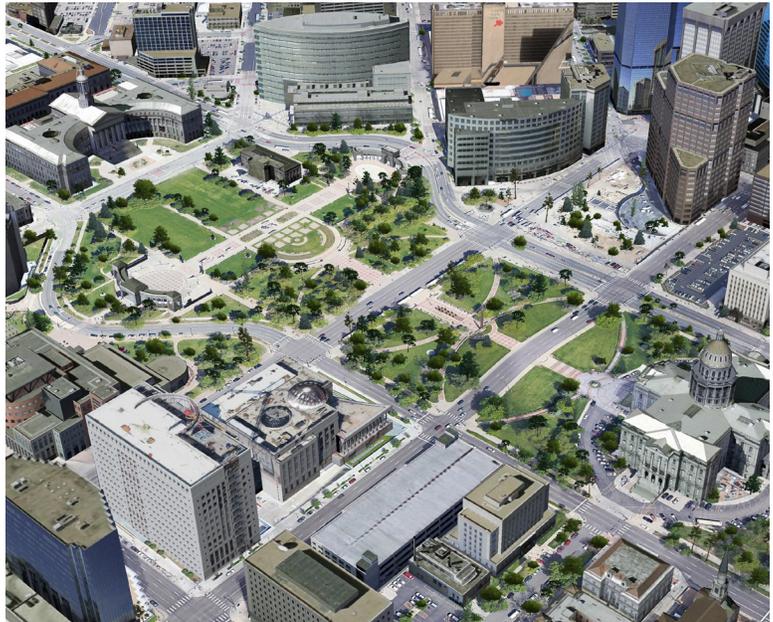
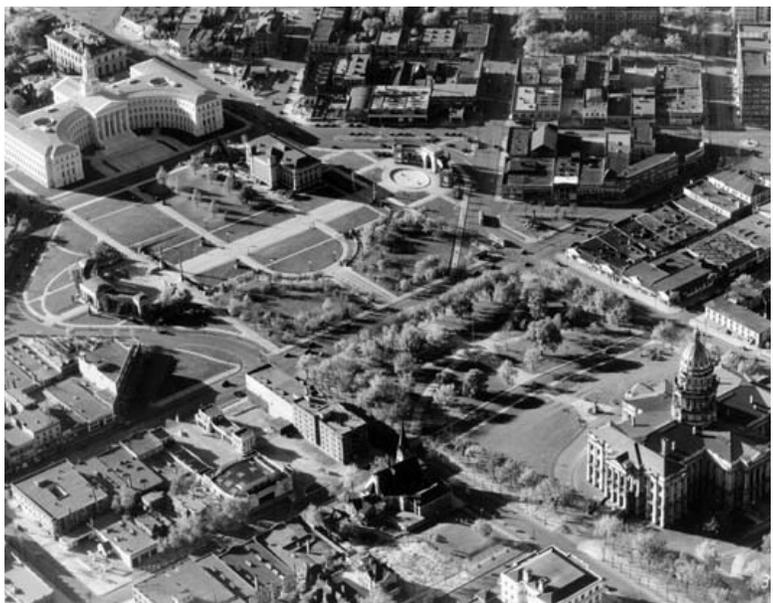
Figure 3-3. Civic Center, c. 2018 (Google Maps).

Civic Center, c. 1931 - 1935. (Denver Public Library Western History Collection)

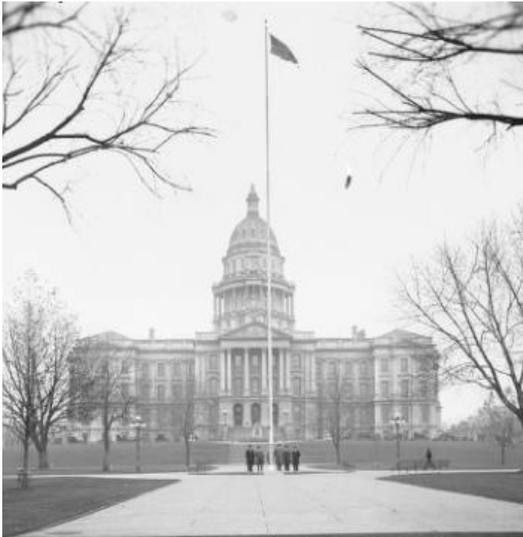
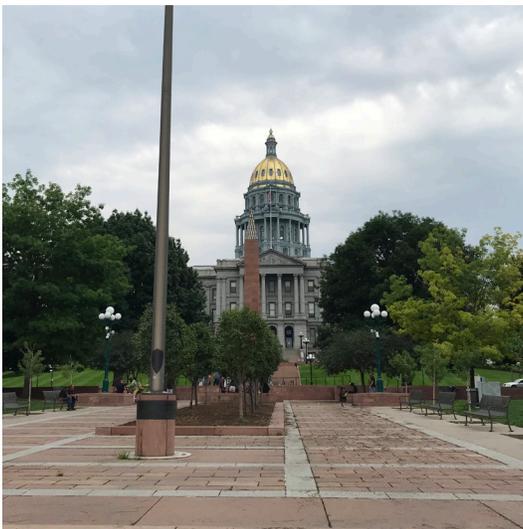
Figure 3-5. Lincoln Park, c. 1920-1930. (Denver Public Library Western History Collection)

Lincoln Park, c. 2018 (Mundus Bishop)

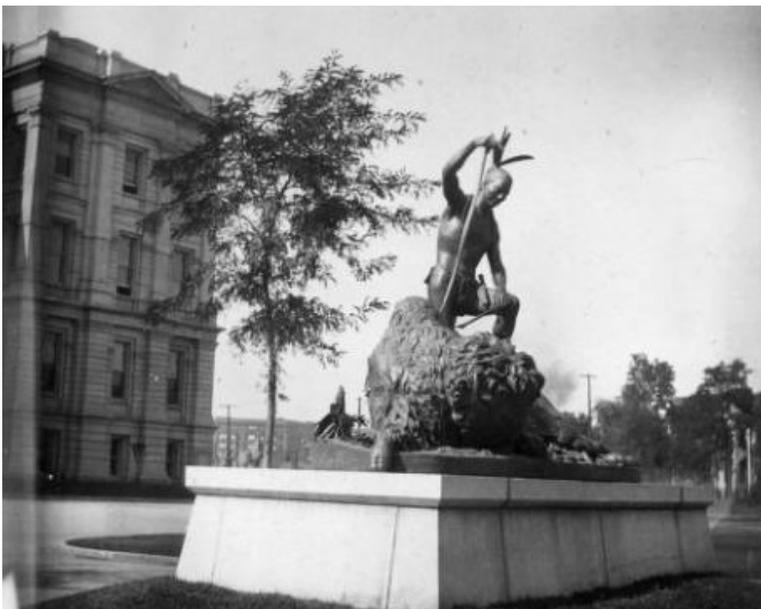
Figure 3-7. *The Closing Era* statue, c. 1890-1900. (Denver Public Library Western History Collection)

*The Closing Era* statue, c. 2018 (Mundus Bishop)

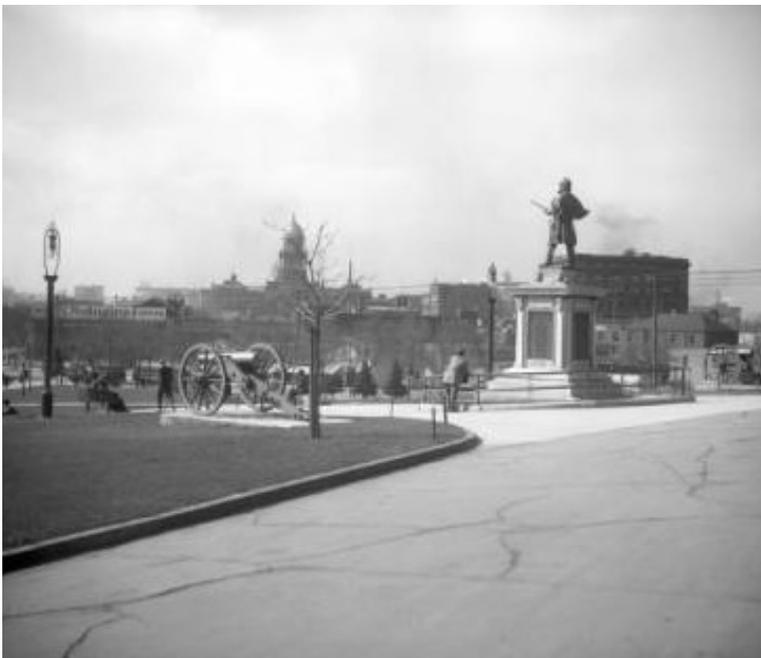
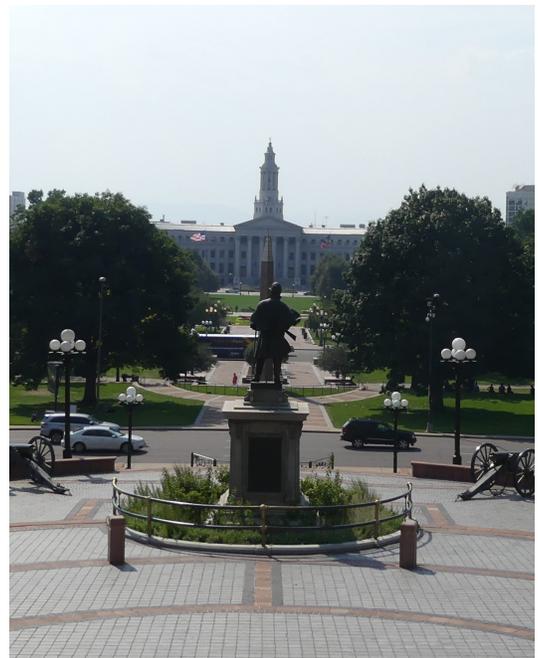
*Colorado Soldiers Monument, c. 2018. (Mundus Bishop, 2018)*

Park use and deferred maintenance impact feature condition. Burrowing animals and loitering deteriorate integrity and contributes to evolving maintenance needs.

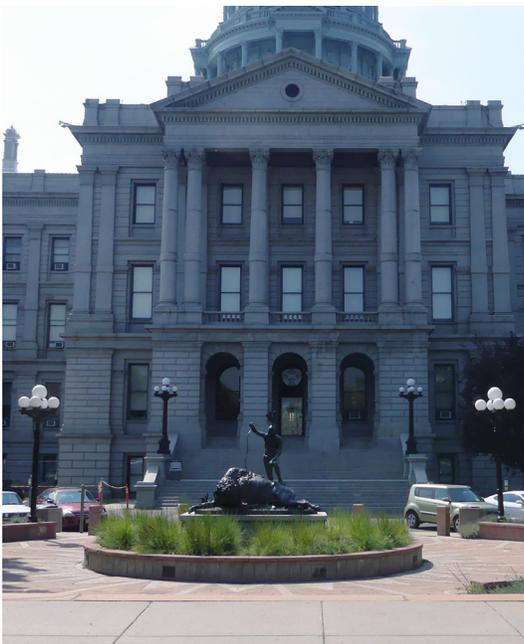
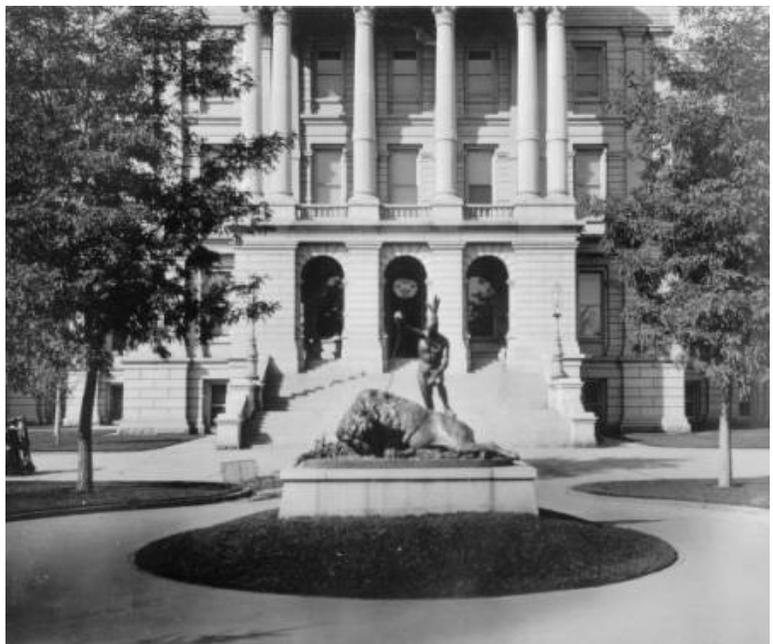
Loop drive, c. 1904. (Denver Public Library Western History Collection)

Loop drive historically provided pedestrian and carriage access to Capitol Building. The narrow carriage road was widened in the 1930s to accommodate vehicular parking. The widened drive, barrier arm gates, and parking encroach on the Capitol Ground’s landscape and views, diminishing the arrival experience and character of the period of significance. Loop drive surfacing is in fair condition. Asphalt overlays address short-term needs but result in unintended impacts to Capitol Building. Stormwater flows over at-grade curbs towards Capitol Building.

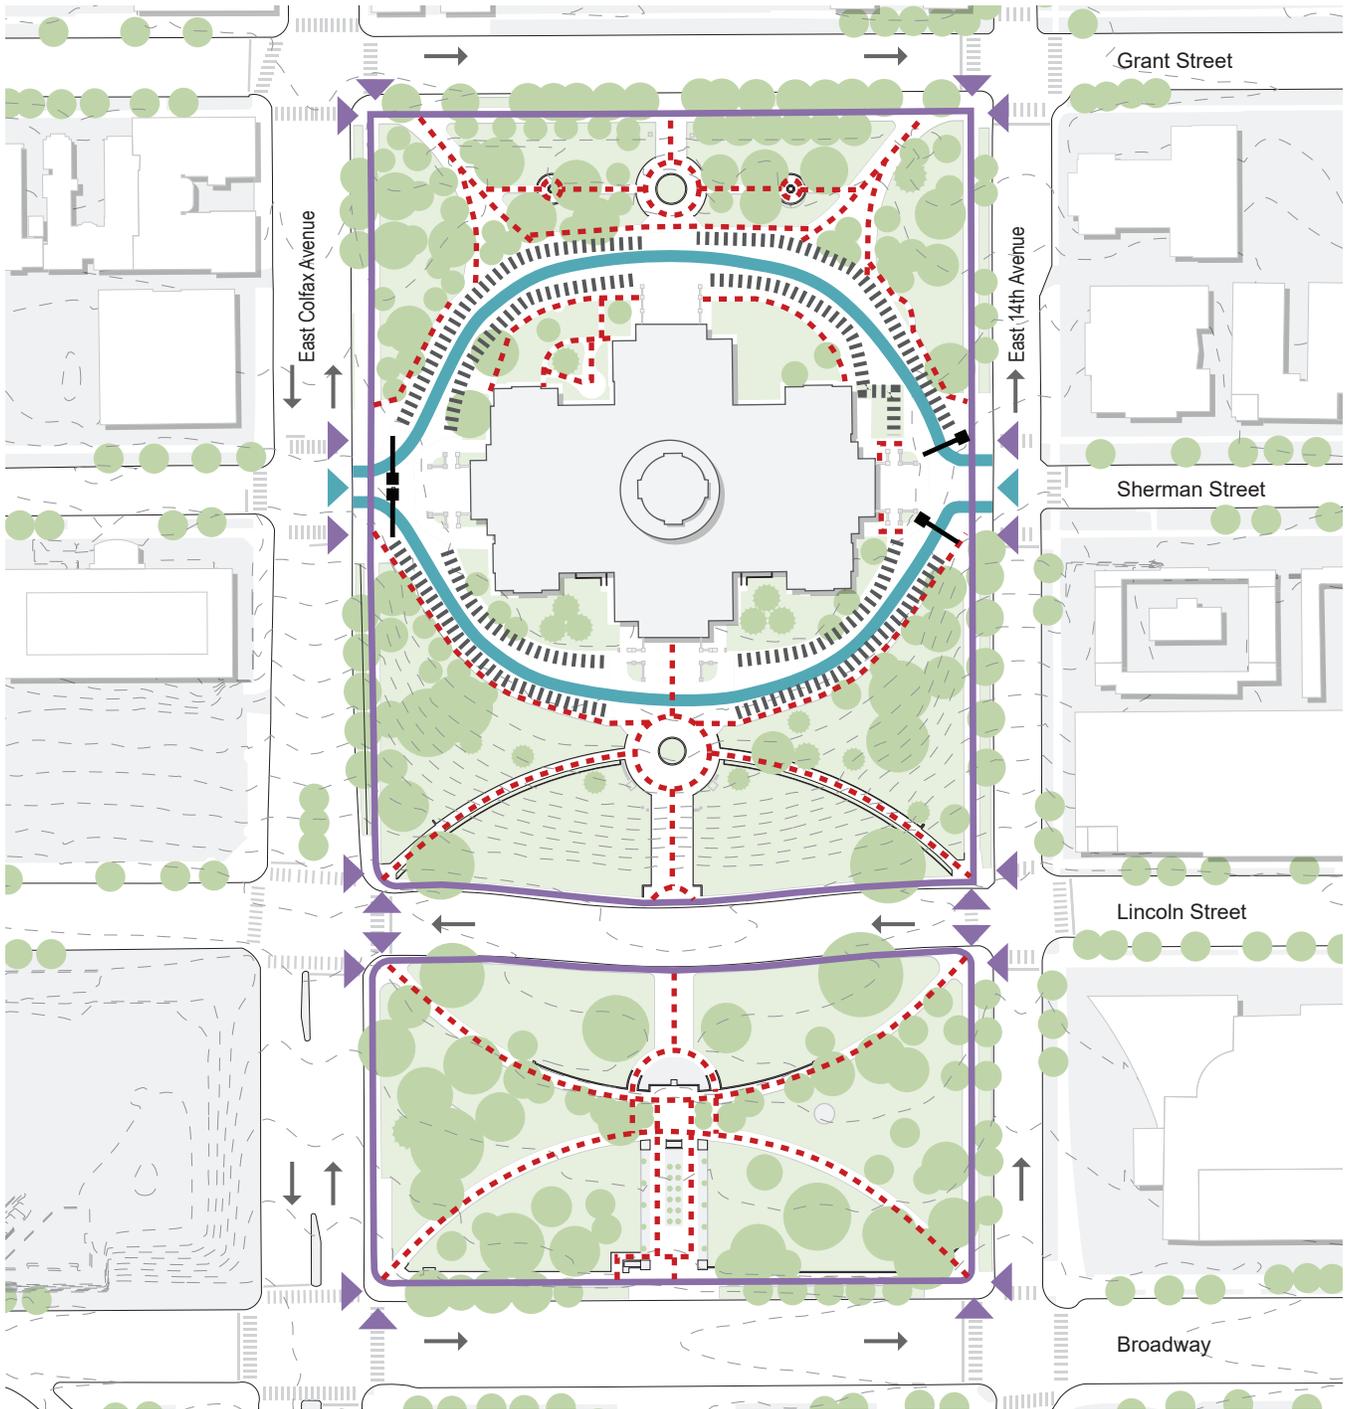
Figure 3-11. Circulation. (Mundus Bishop, 2019)

Study area circulation includes vehicular and pedestrian routes. Current circulation reflects historic routes, although widths and materials differ from the period of significance. Vehicular parking exists along loop drive, historically a pedestrian and carriage route. Additional pedestrian walks occur in areas of historically open lawn. Contemporary projects introduced paving patterns and a wider range of materials replacing Schuetze’s simple paving palette.

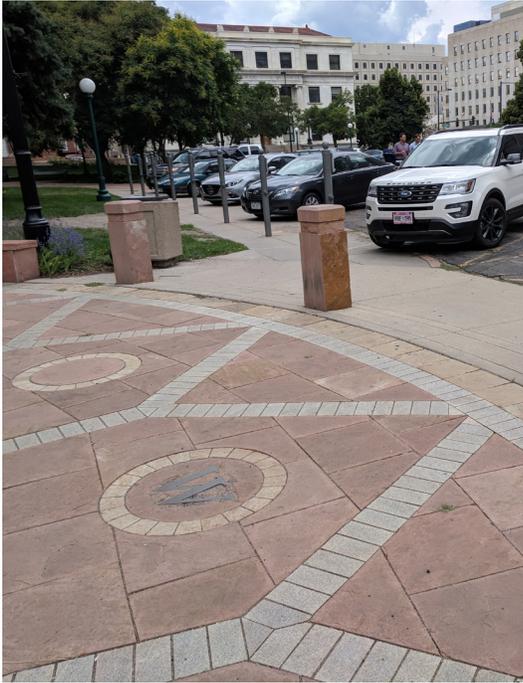
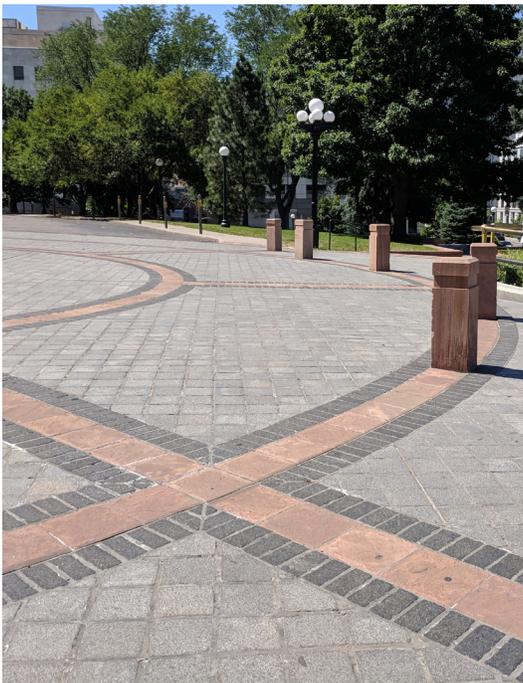
Figure 3-12. *The Closing Era* statue plaza (Mundus Bishop, 2018)

Colorado Veteran's Plaza (Mundus Bishop, 2018)

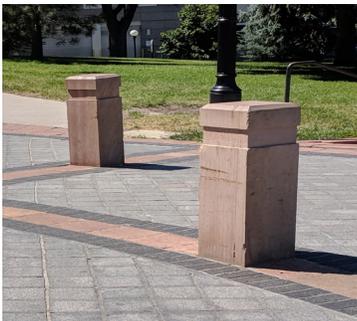
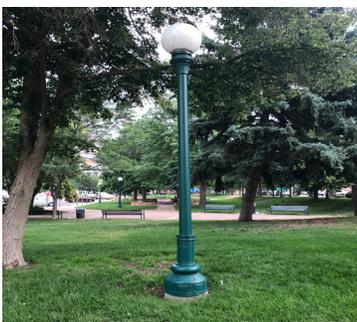
Small scale features respond to contemporary access, safety, and operational needs. Bollards, vehicular gates, and regulatory signage do not reflect the study area's historic character or experience.

Figure 3-13. Existing small scale features. (Mundus Bishop, 2018)

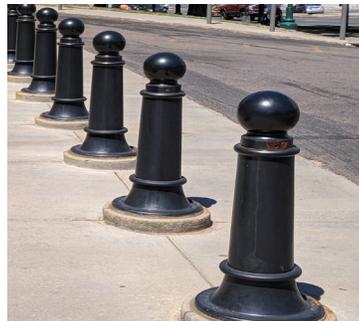
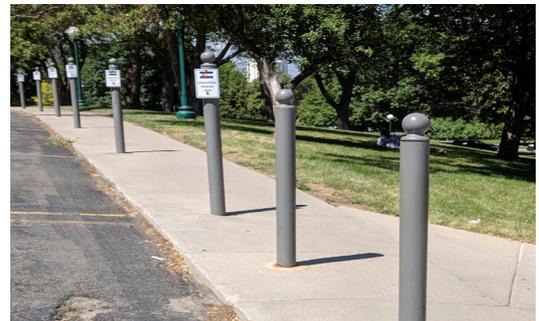
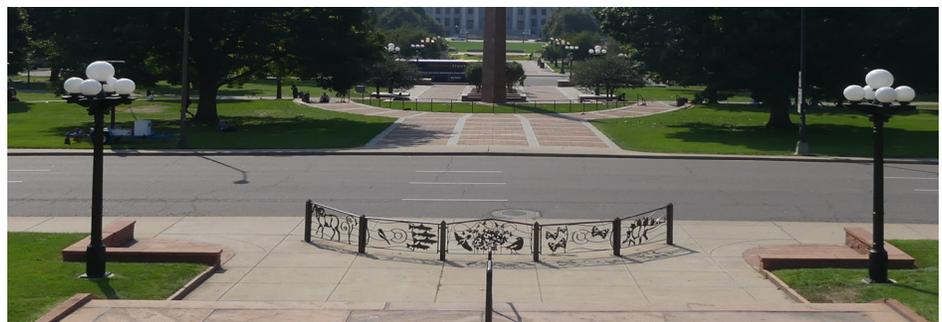
During the period of significance small scale features included benches, decorative fencing, and lighting. These features were removed or replaced with contemporary design choices. Small scale features within the historic landscape were consistent and simple in style and materials. Contemporary features are inconsistent—benches, bollards, and light fixtures vary in style and material throughout the grounds.

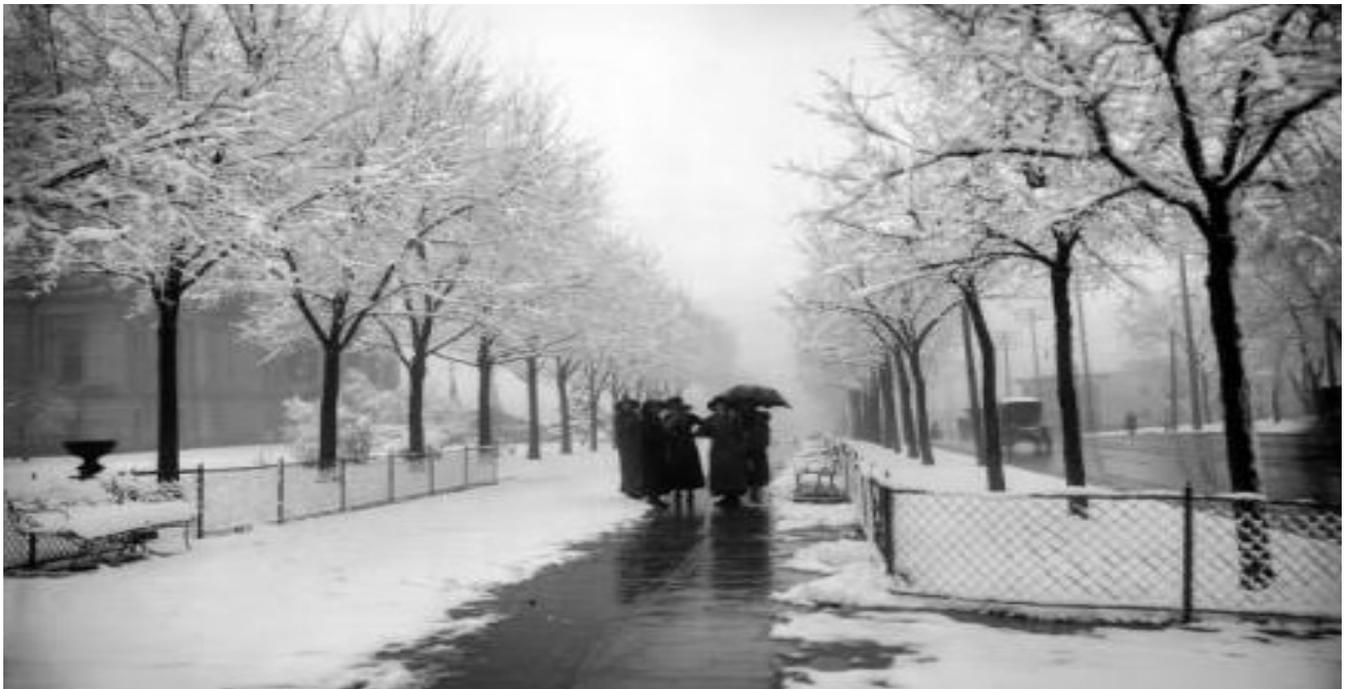
During the period of significance, a continuous double-row of elms created formal allees. The shaded walks established a unifying element throughout the study area. Allees are visible today but gaps exist where trees have died or been removed. Few original elms remain, and the tree-lined walks lack the historic density and regularity of paired trees. Replacement trees vary in size, spacing and species.

Figure 3-14. Formal tree-lined walks, c. 1913. (Denver Public Library Western History Collection)

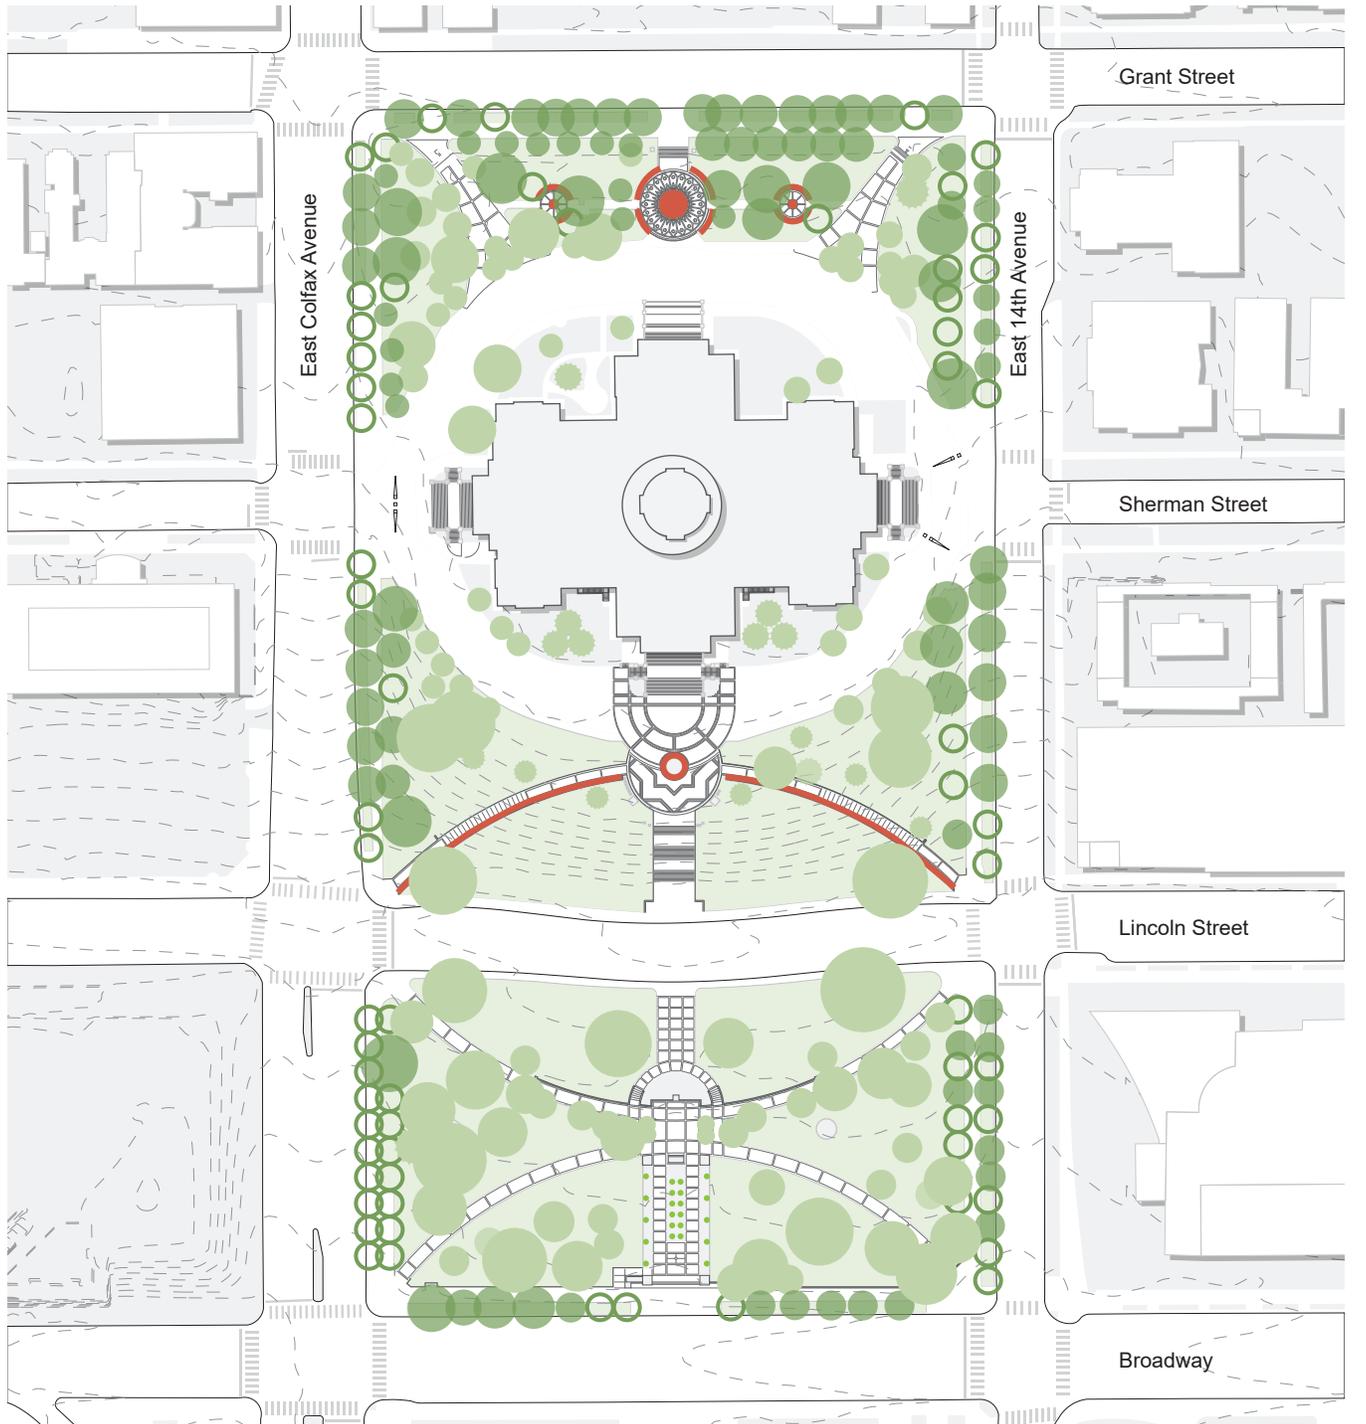
Figure 3-15. Vegetation. (Mundus Bishop, 2019)

**Groves of trees** are located in East Lawn, Lincoln Park, and along loop drive. The groves resemble Schuetze’s original plantings but are denser and extend into areas of historically open lawn in East Lawn and along loop drive. Tree replacement has not occurred in Lincoln Park and fewer trees exist than in the period of significance.

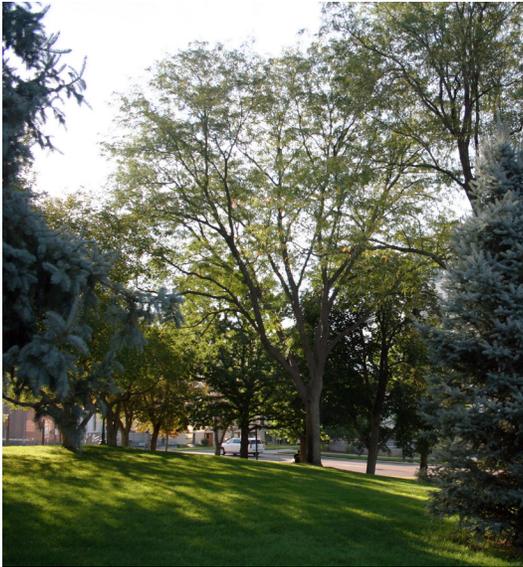
Figure 3-16. West lawn groves of trees. (Mundus Bishop, 2018)

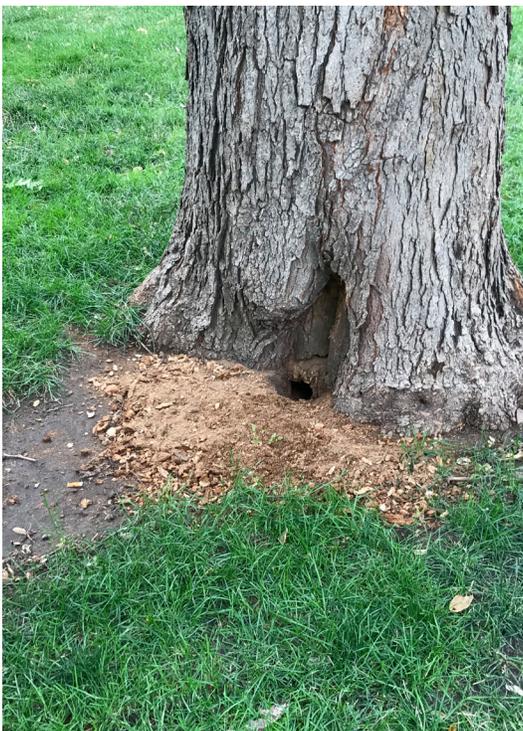
Figure 3-17. Burrowing animals impact trees. (Mundus Bishop, 2018)

Shade tree condition varies. Deferred maintenance and burrowing animals impact tree condition and contribute to deterioration.

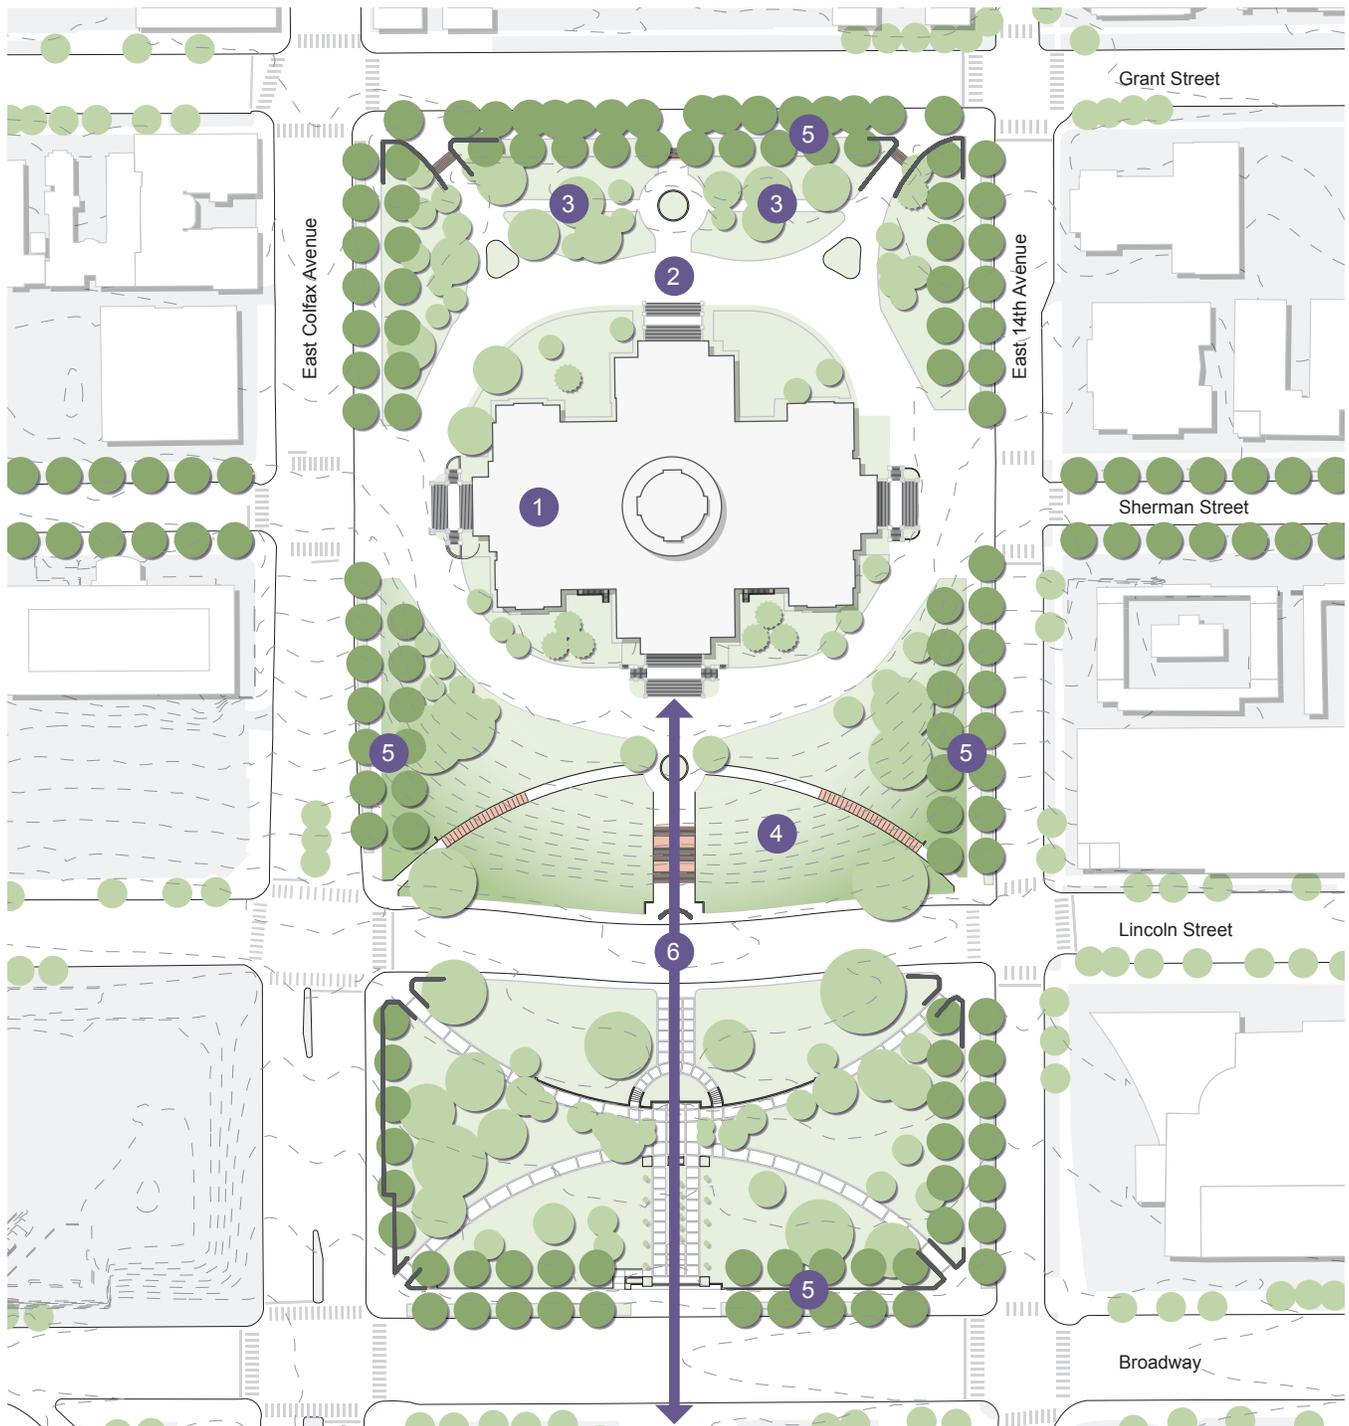
Figure 4-1. Treatment Plan. (Mundus Bishop, 2019)

- 1 Preserve Capitol Building as Colorado State Capitol Grounds' Focal Point
- 2 Rehabilitate Loop Drive
- 3 Establish Memorial Walk
- 4 Preserve the Topography of Brown's Bluff
- 5 Preserve and Restore Perimeter Allees
- 6 Preserve and Strengthen Civic Axis
