Water Resources & Agriculture Review Committee

Wildfire Restoration Update

Northern Water

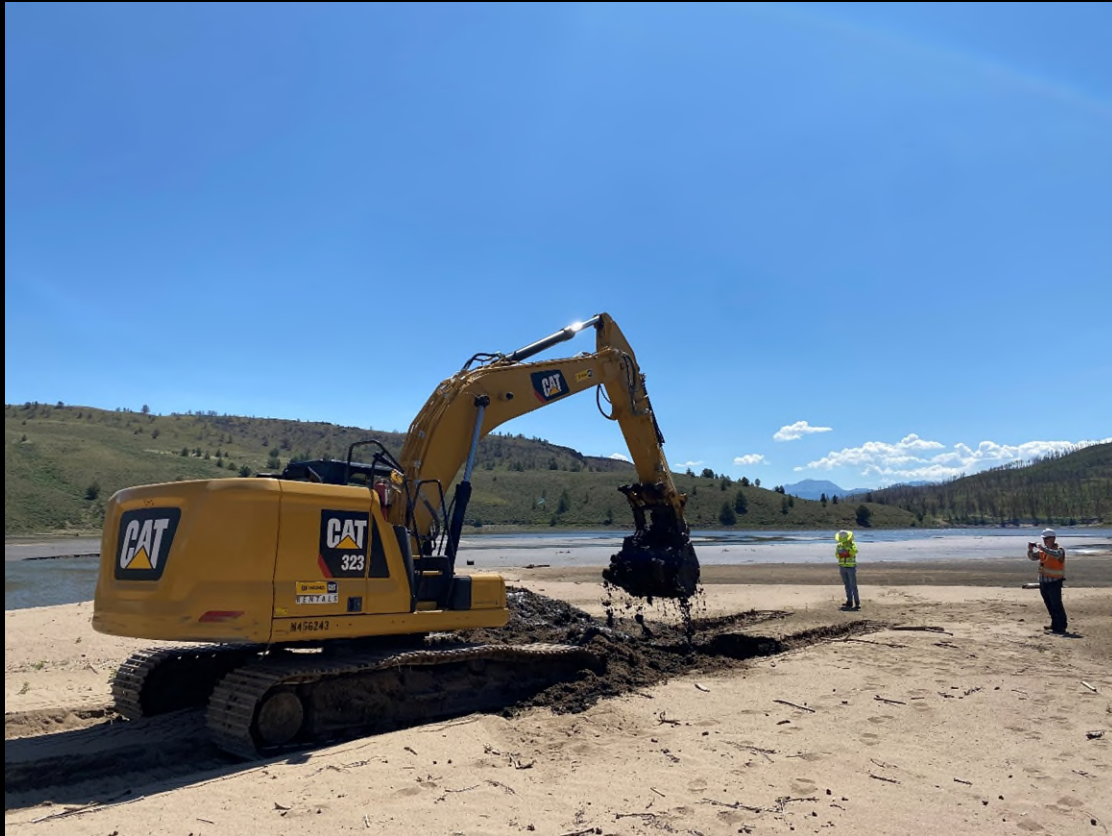
Test pits at Willow Creek Reservoir Berm location for geotechnical investigation 7/22

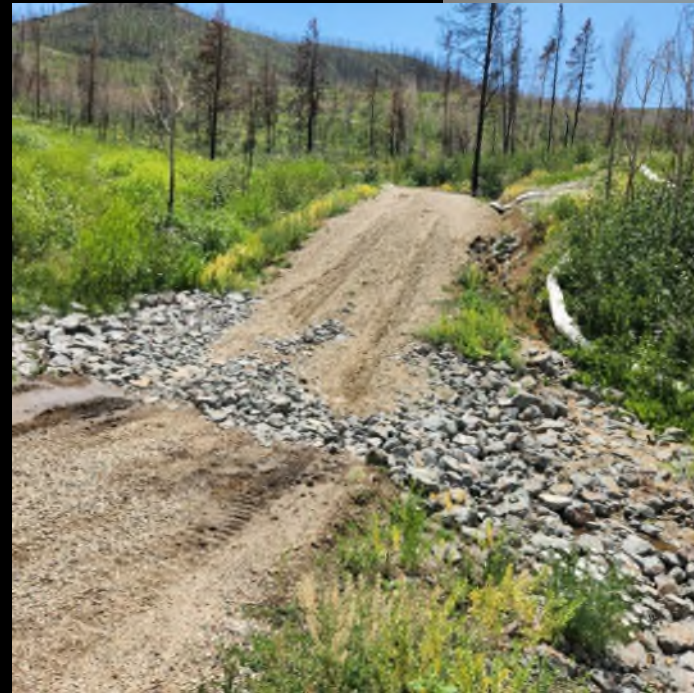
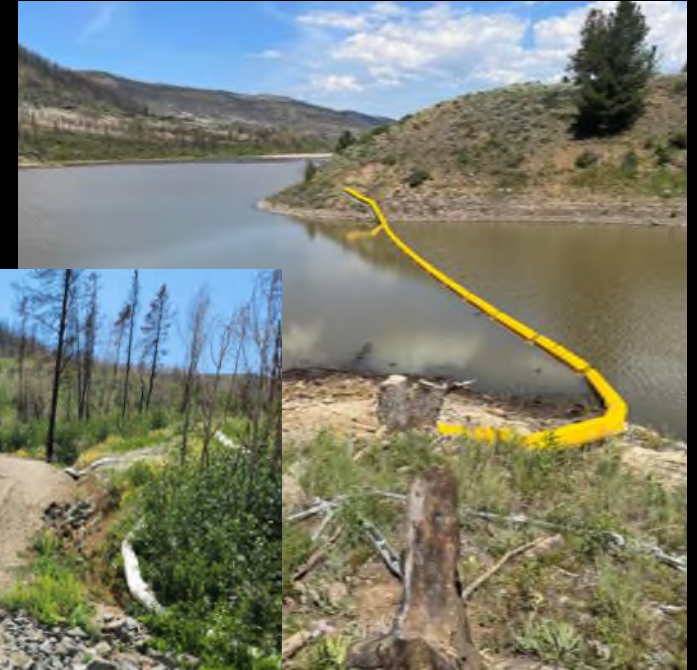
Willow Creek Inlet
Debris Boom Access
Road Repair and
O&M 7/27

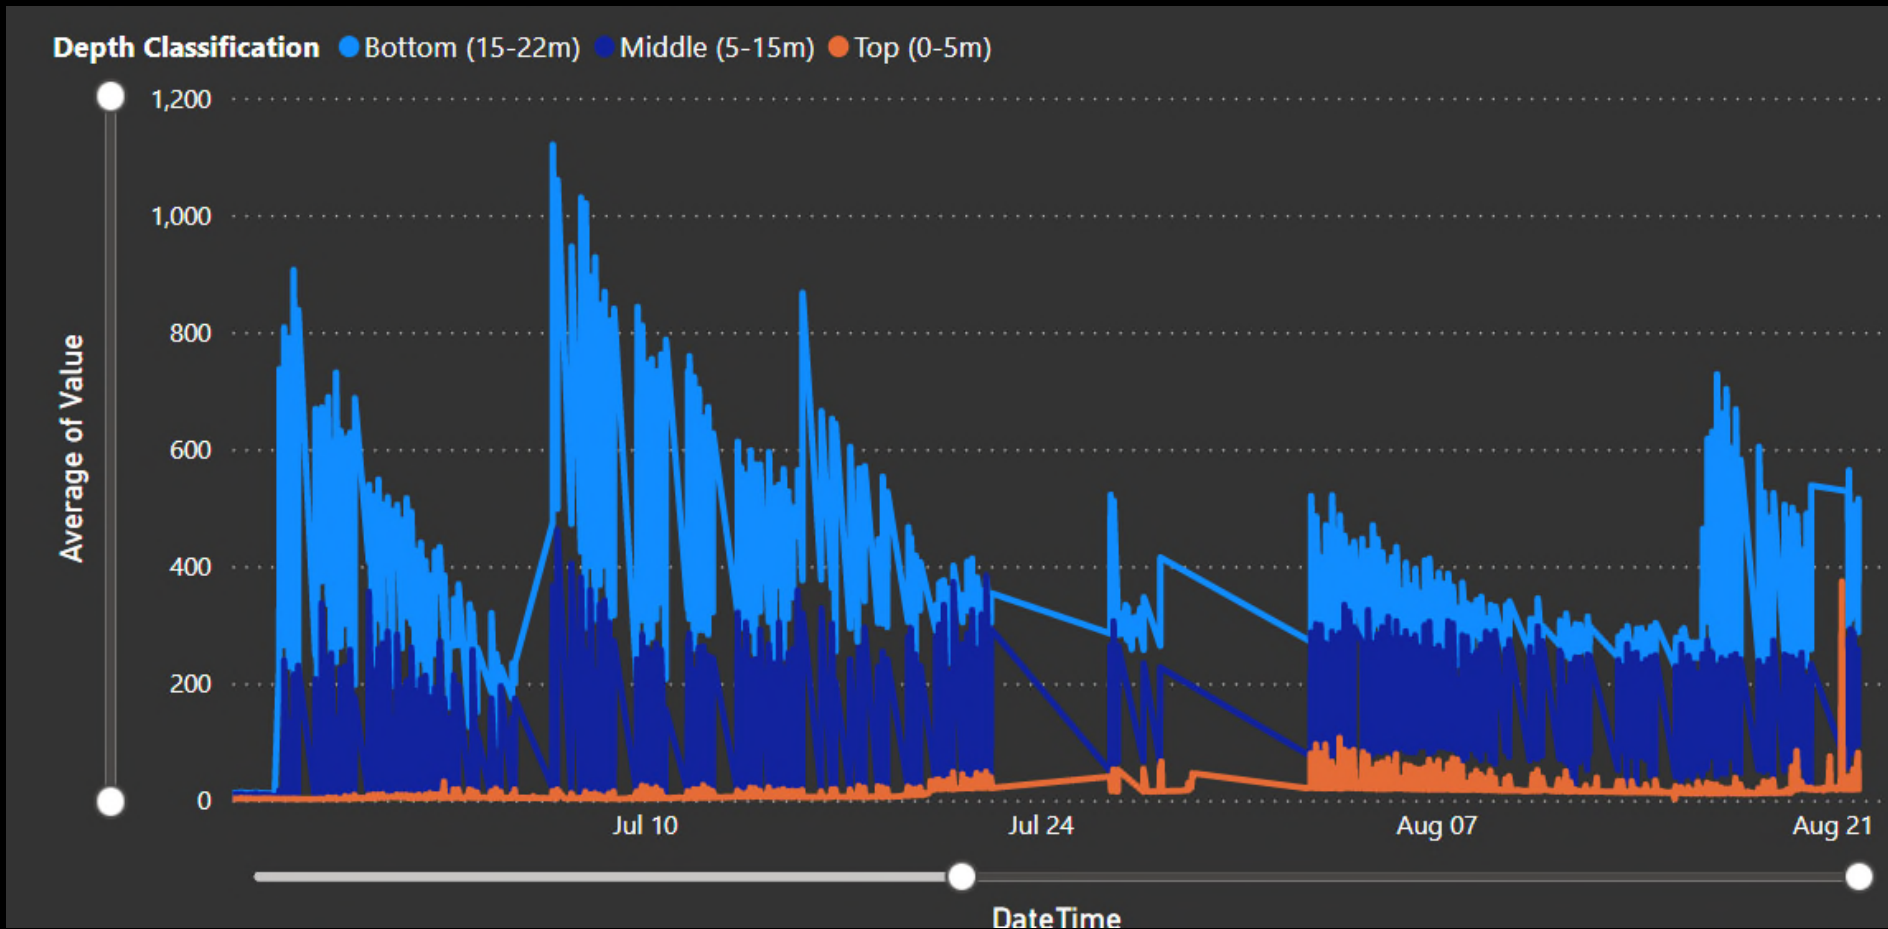
Willow Creek Reservoir Turbidity (NTU)

> 100 not
treatable
